# Manhole Inspection Summary

Manhole # S25E1\_004MH

Insp Date: **4/17/08 1:17 PM**

**Location** Address: **2801 INDIANA ST.**

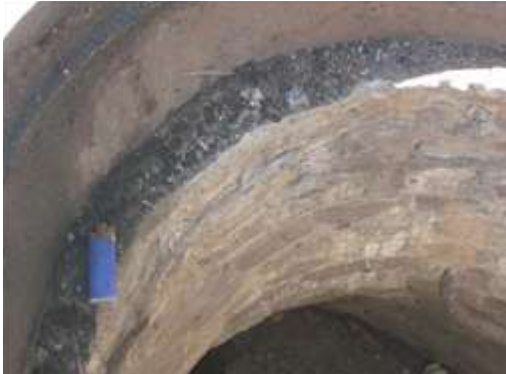
Defect 5

**Frame** Offset: **1.5** (in.) Condition: ☒ Sound ☐ Cracked ☐ Leaks

1.5 FRAME OFFSET WITH EVIDENCE OF SURCHARGE

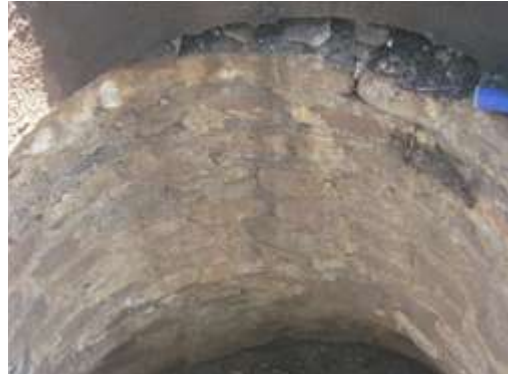
Defect 4

Condition: ☐ Sound ☐ Cracked ☐ Root Intrusion ☒ **Loose Brick** ☐ Deteriorated

Infiltration: ☐ None ☐ Joint ☐ Cracks ☒ **Mortar** ☐ Roots ☐ Wall

MISSING MORTAR AND BRICK WITH EVIDENCE OF CHIMNEY INFILTRATION

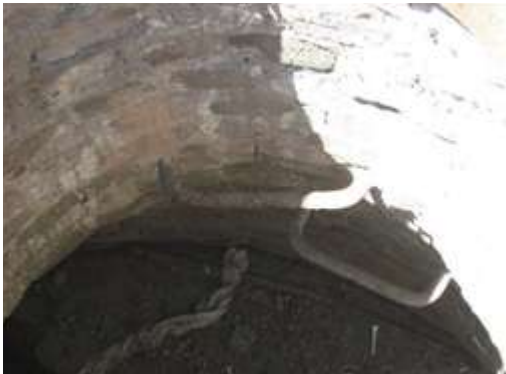
Defect 2

Infiltration: ☐ None ☐ Joint ☐ Cracks ☒ **Mortar** ☐ Roots ☐ Wall

EVIDENCE OF CORBEL INFILTRATION

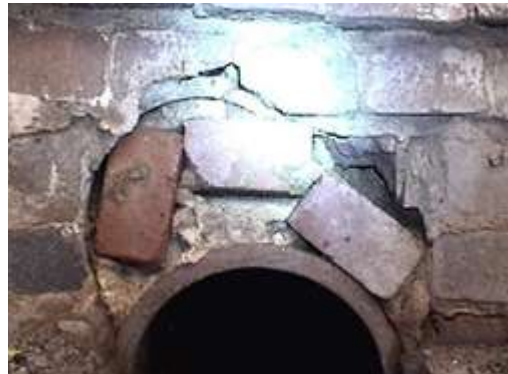
Defect 1

Condition: ☐ Sound ☐ Cracked ☐ Root Intrusion ☒ **Loose Brick** ☒ **Deteriorated**

LOOSE BRICK AND MISSING MORTAR IN BARREL

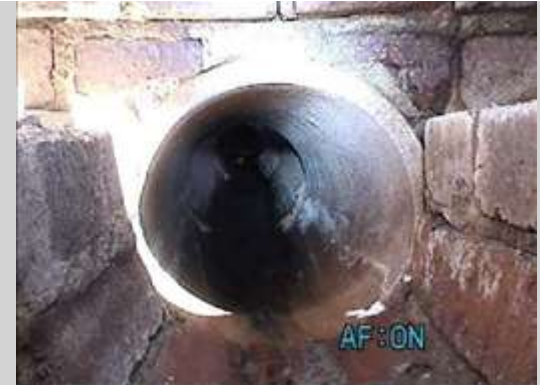
12 O'Clock Outflow

Infiltration: **None** Pipe Seal Cond: **Sound**

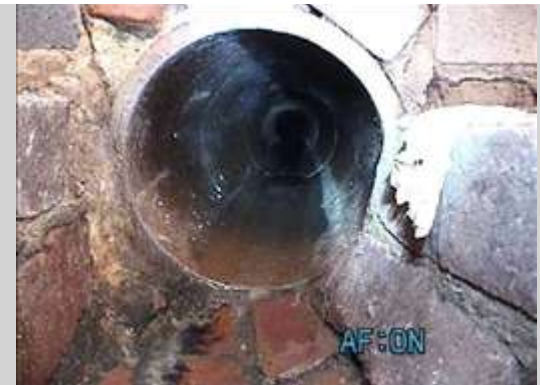
6 O'Clock Inflow

Infiltration: **None** Pipe Seal Cond: **Sound**
